**Flood Control Project Maintenance
Levee Inspections****LMA District Cover Sheet****Spring 2012 Levee Inspection Results****Levee District No. 0009 (Sutter County)**

Waterway			Bank	Unit Miles
Unit No. 01 Sutter County, Feather River			Right	6.24
	Spring (March - May)	Summer (June - August)	(September - November) Fall	Winter (December - February)
Unit Maintenance Rating (Fall Only)				
Date of Inspection	3/26/2012 - 3/26/2012			
DWR Inspector	Clay Thomas			
Accompanied By	David Schmidl LD 9 Sutter

Levee Inspection Report By Mile - Spring 2012

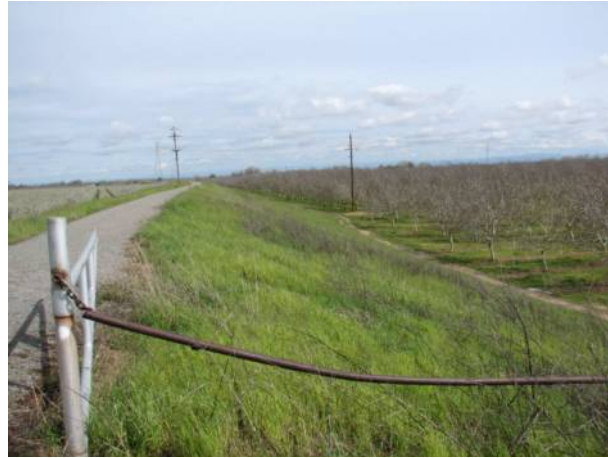
cathom_s_20120329_415.JPG

Levee Mile Report Line	4
Start Levee Mile	0.07
End Levee Mile	5.67
Location	Water Side
Category	Earthen Levee
Item	Vegetation

This photo was taken at levee mile 0.00 looking upstream at the waterside vegetation.

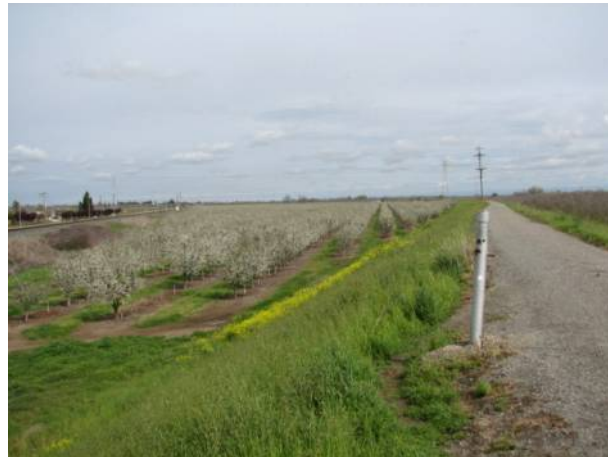
cathom_s_20120329_416.JPG

Levee Mile Report Line	5
Start Levee Mile	0.07
End Levee Mile	6.22
Location	Land Side
Category	Earthen Levee
Item	Vegetation

This photo was taken at levee milie 0.00 looking upstream at the landside vegetation.

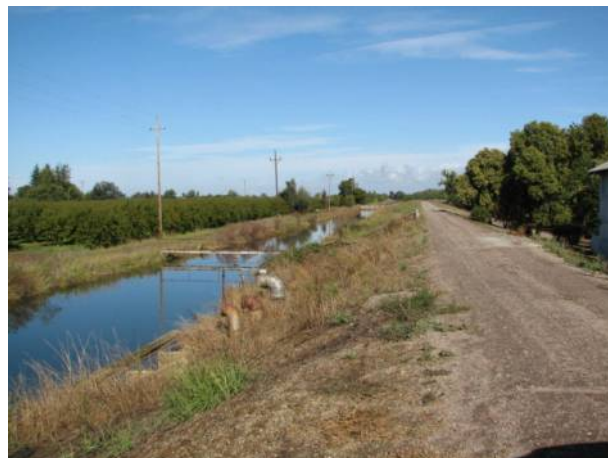
cathom_s_20120307_005.jpg

Levee Mile Report Line	9
Start Levee Mile	5.68
End Levee Mile	6.02
Location	Land Side
Category	Earthen Levee
Item	Encroachments

Agricultural ditch at land side toe.

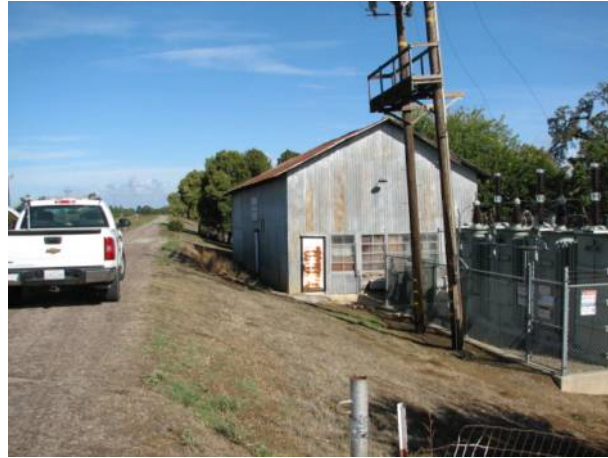
cathom_s_20120307_004.jpg

Levee Mile Report Line	10
Start Levee Mile	5.68
End Levee Mile	5.68
Location	Water Side
Category	Earthen Levee
Item	Encroachments

Building at the water side toe.
